13 January 2021

**CAPITAL NEEDS ASSESSMENT**  
FOR  
**CAMPELLO APARTMENTS**

BWA Project No. 2009A

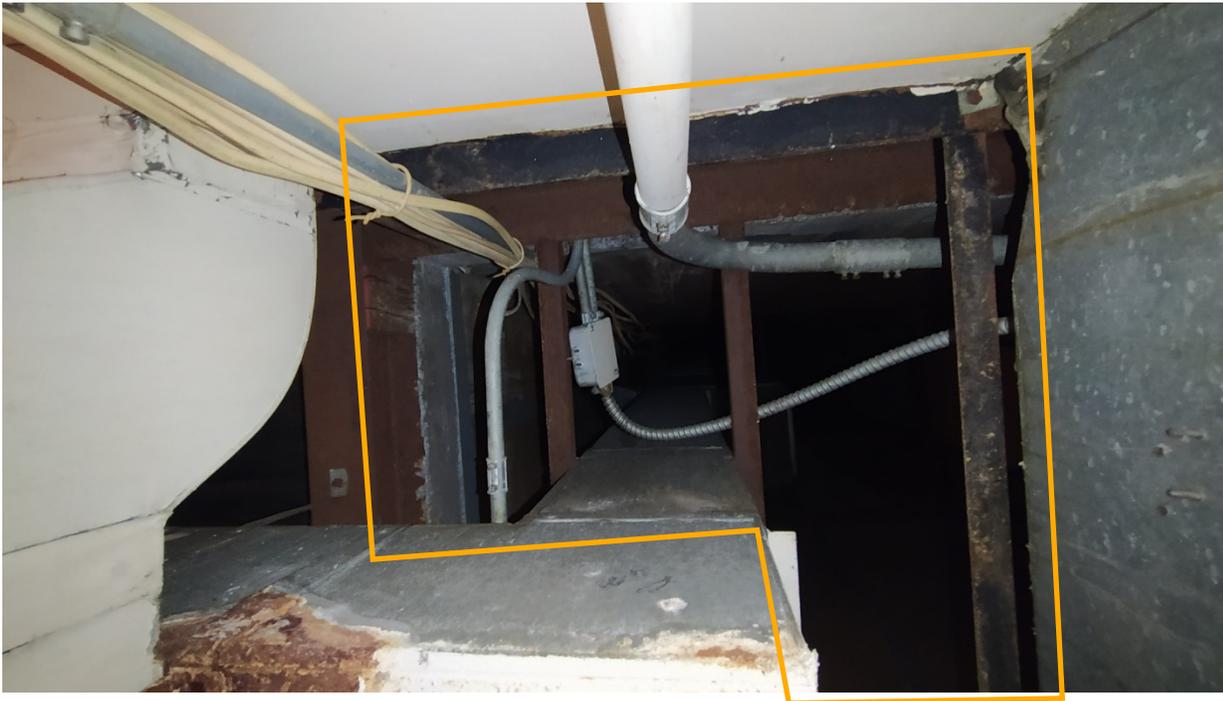
Another concern is that the buildings are significantly out of compliance with modern building code requirements, especially with regard to high-rise buildings, structural capacity, and energy conservation. In some respects, especially fire safety, these code compliance concerns pose a potential threat to the safety of the residents. High-rise codes have advanced significantly over the past half century: while the buildings may have met code requirements when built, they are significantly under-served when reviewed against modern standards. To worsen matters, alterations to the buildings over the years have impaired fire safety. These include enclosing the smoke vestibules at the end fire stairs and removal of fire separation assemblies throughout the structures to access leaking pipes for repairs (Figure 1.3).

Figure 1.3: Unprotected open 10-story shaft adjacent to south stair in Building B.

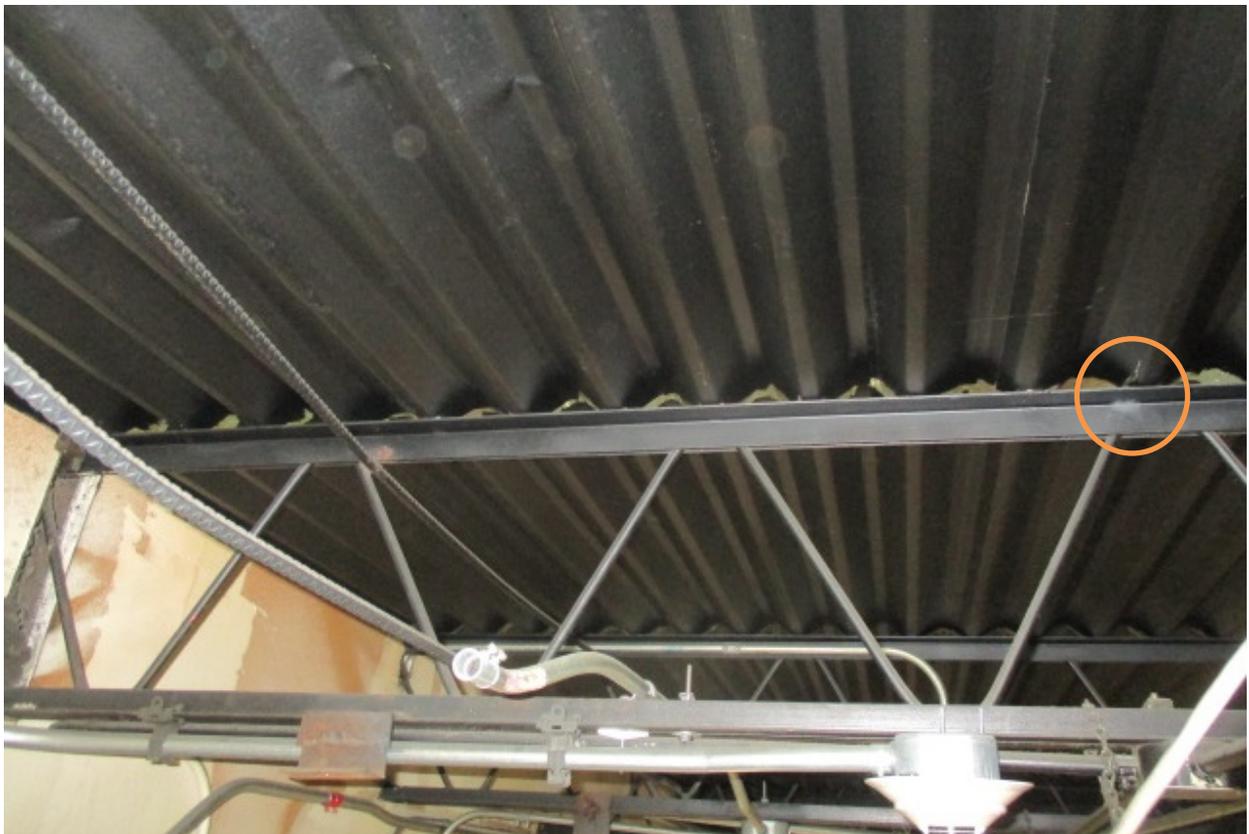
The problem is exacerbated by poor initial construction quality control: we noted numerous deficiencies in the steel framing that suggest the structures were not adequately inspected to ensure the buildings were constructed in compliance with the original design. (See Figures 1.4 – 1.6 below and on following page) In addition, we reviewed documentation prepared during construction that indicates that construction was stopped at least once by local officials due to concerns that required structural testing and inspections were not being adequately performed. As a result, already under-sized structural frames are further impaired by shoddy construction.

*Figure 1.4: Metal decking is infrequently and poorly welded to bar joists (typical condition).*

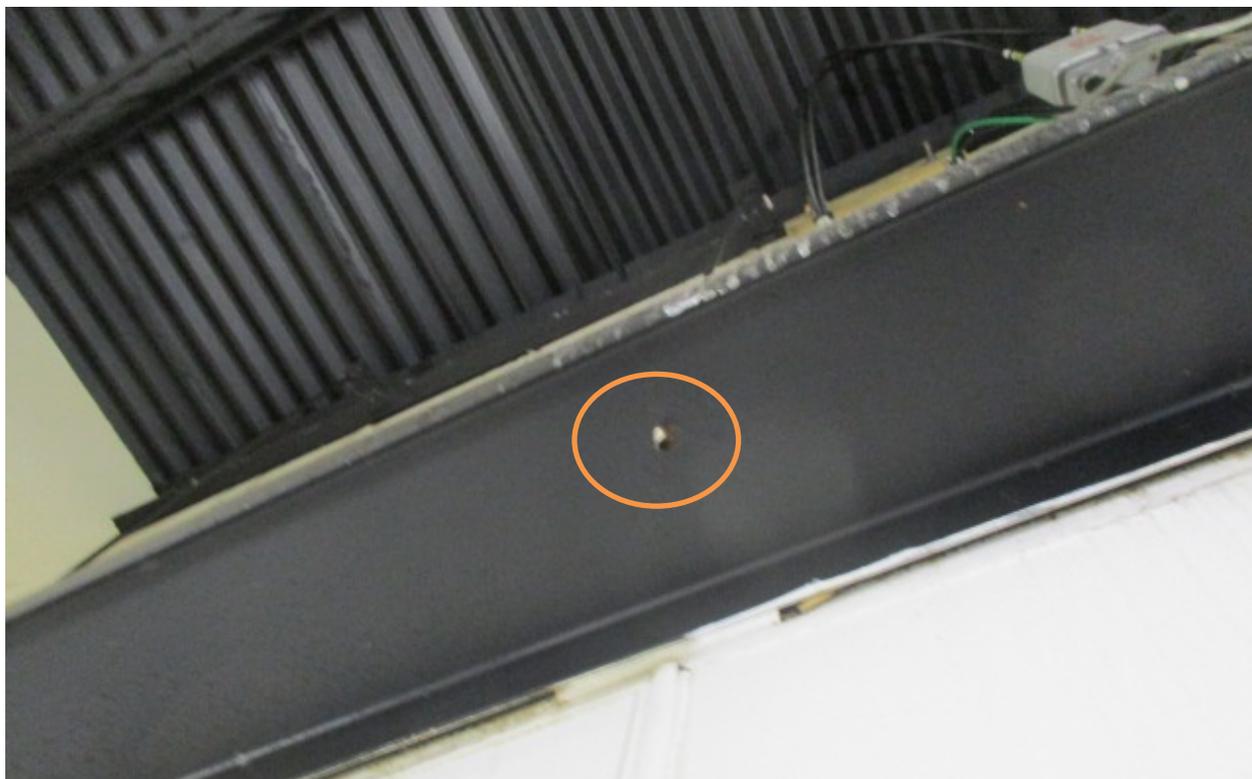
Figure 1.5: Missing sag rod at exterior wind girt.

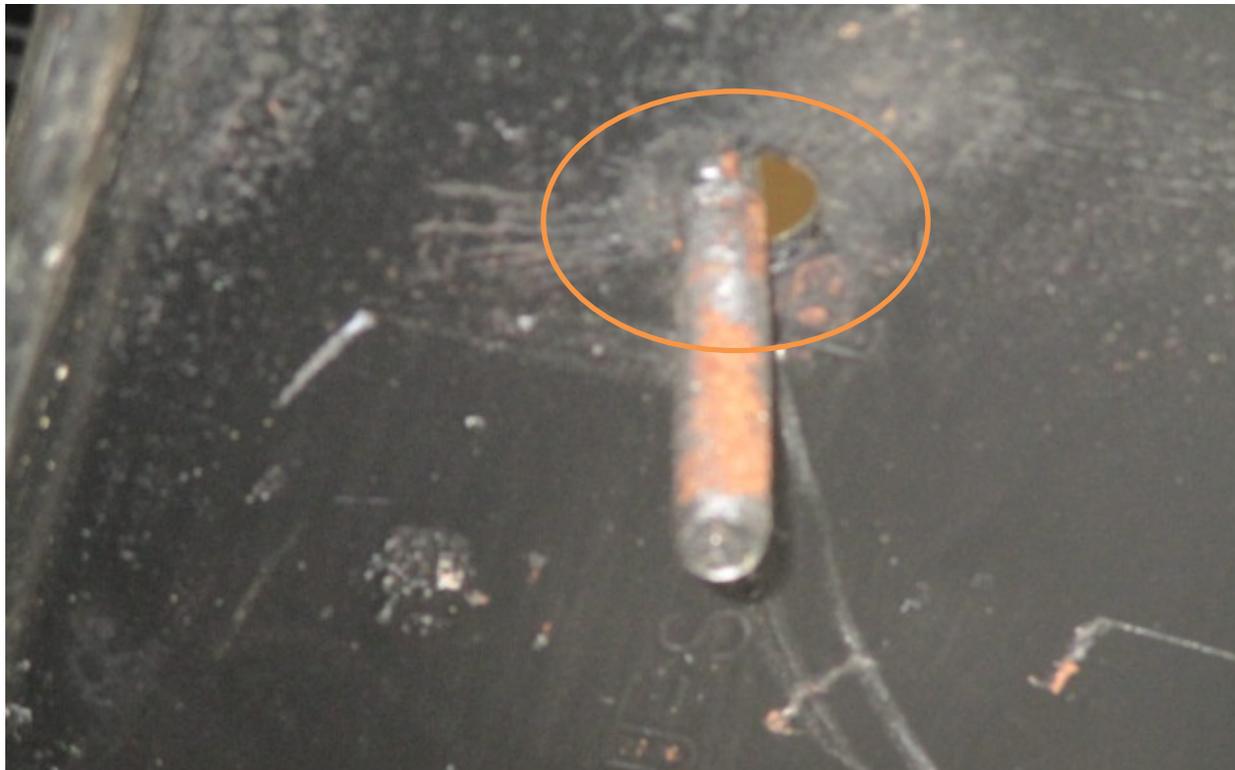
Figure 1.6: Missing connection nuts and washers at sag rod at exterior wind girt.

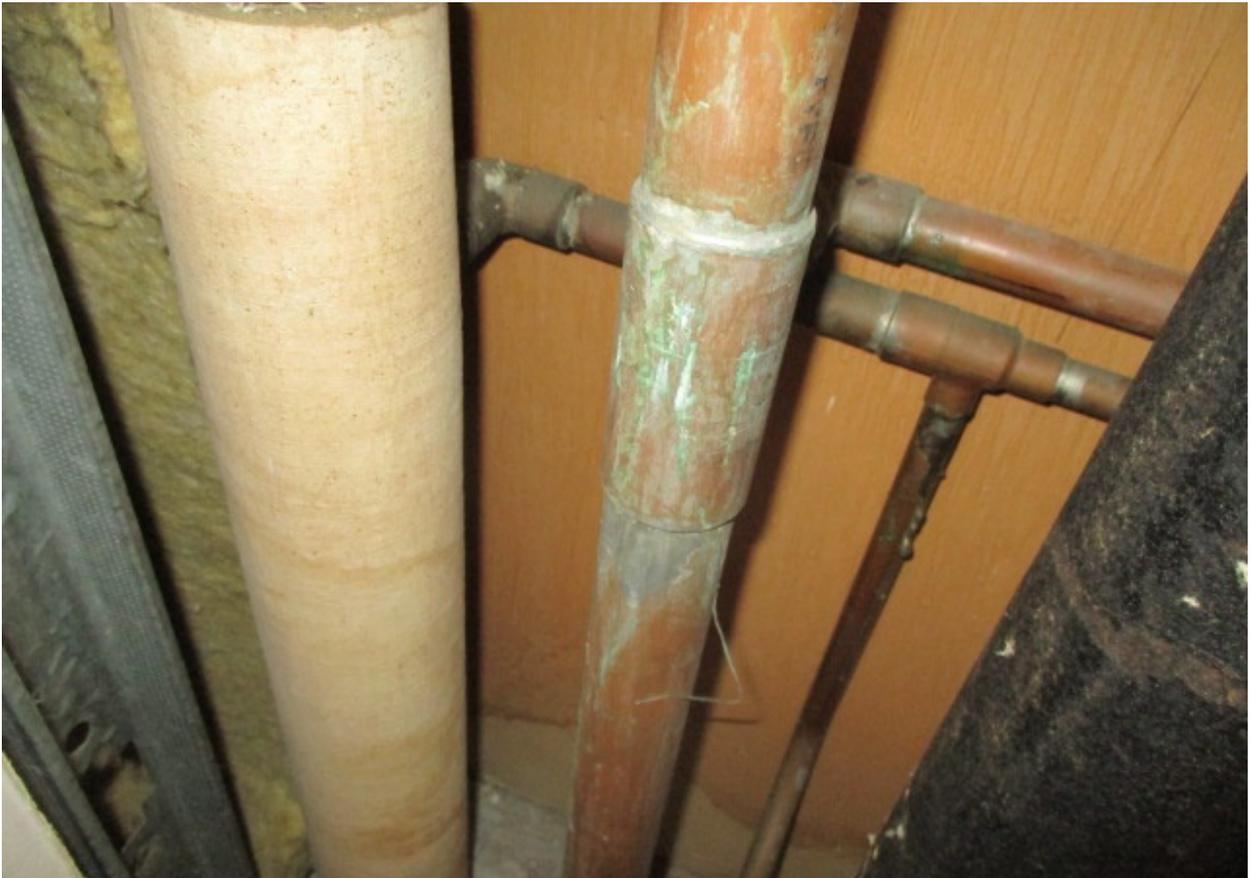
Mechanical systems original to the building are also highly inefficient. The units are heated by electric resistive heat baseboards, the least efficient heating system. Original plumbing fixtures and fittings are not water conserving (some have been replaced). Virtually all of the domestic hot water supply risers we were able to inspect are not insulated (see Figure 1.7). Lighting is generally relatively inefficient compact fluorescent.

*Figure 1.7: Uninsulated domestic hot water riser (typical); also note heavy corrosion on piping.*

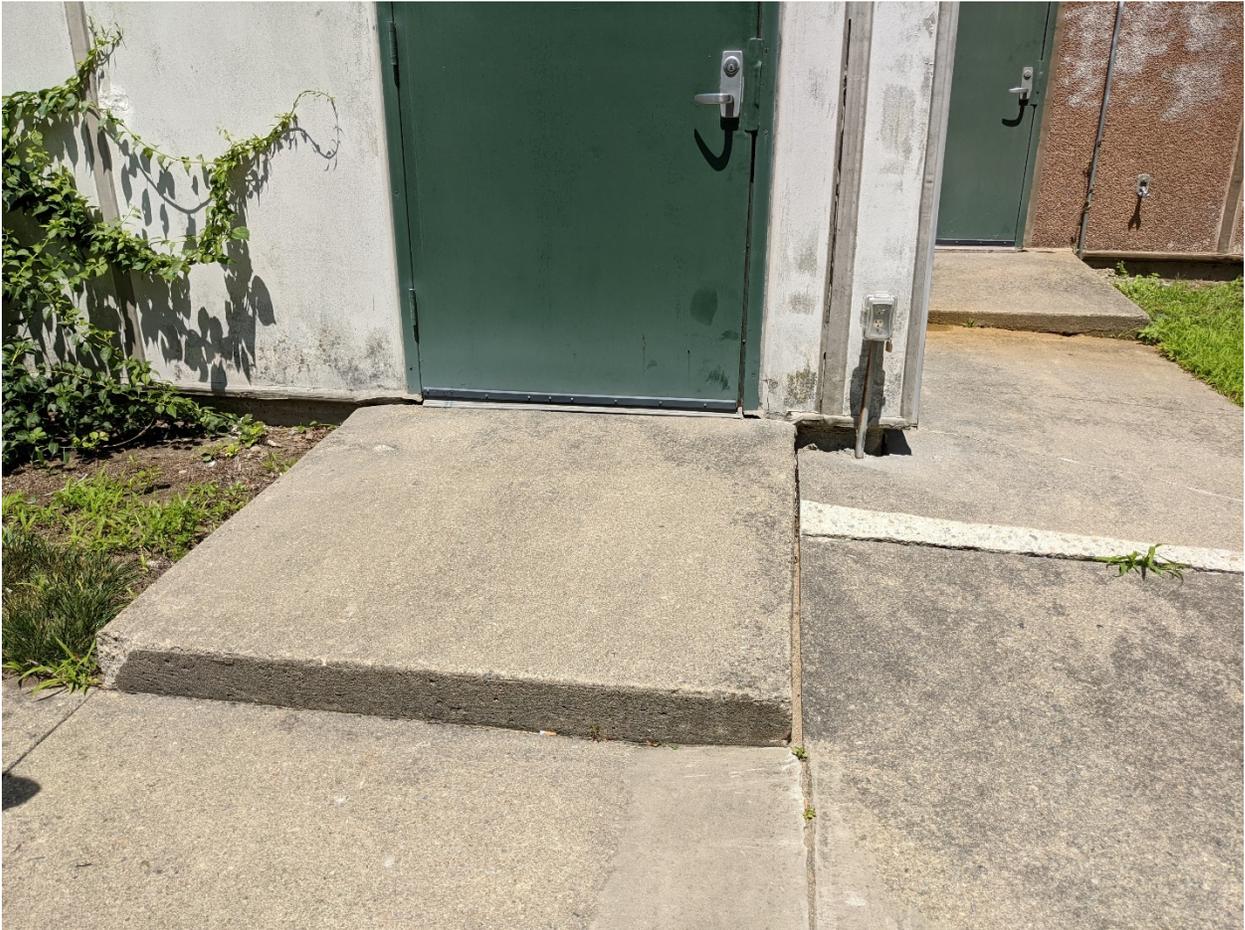
Walkways around the property are cast-in-place concrete in varying condition; a few cracks and tripping hazards are present, even in otherwise generally sound panels. (Figure 2.0) Because of frost heaving and subsidence or shoddy initial construction, some walkways are not accessible due to unacceptable cross slopes. (Also shown in Figure 2.0) Most site concrete appears to be original to buildings and in poor condition; these portions of walkways should be replaced in the near future. There are single riser steps at several of the stair tower discharge walks, which do not meet code and will require regrading for code compliance. (Also shown in Figure 2.0)

*Figure 2.0: Steps at exterior exit discharge; heaved sidewalk panels create a tripping hazard and ADA violation*

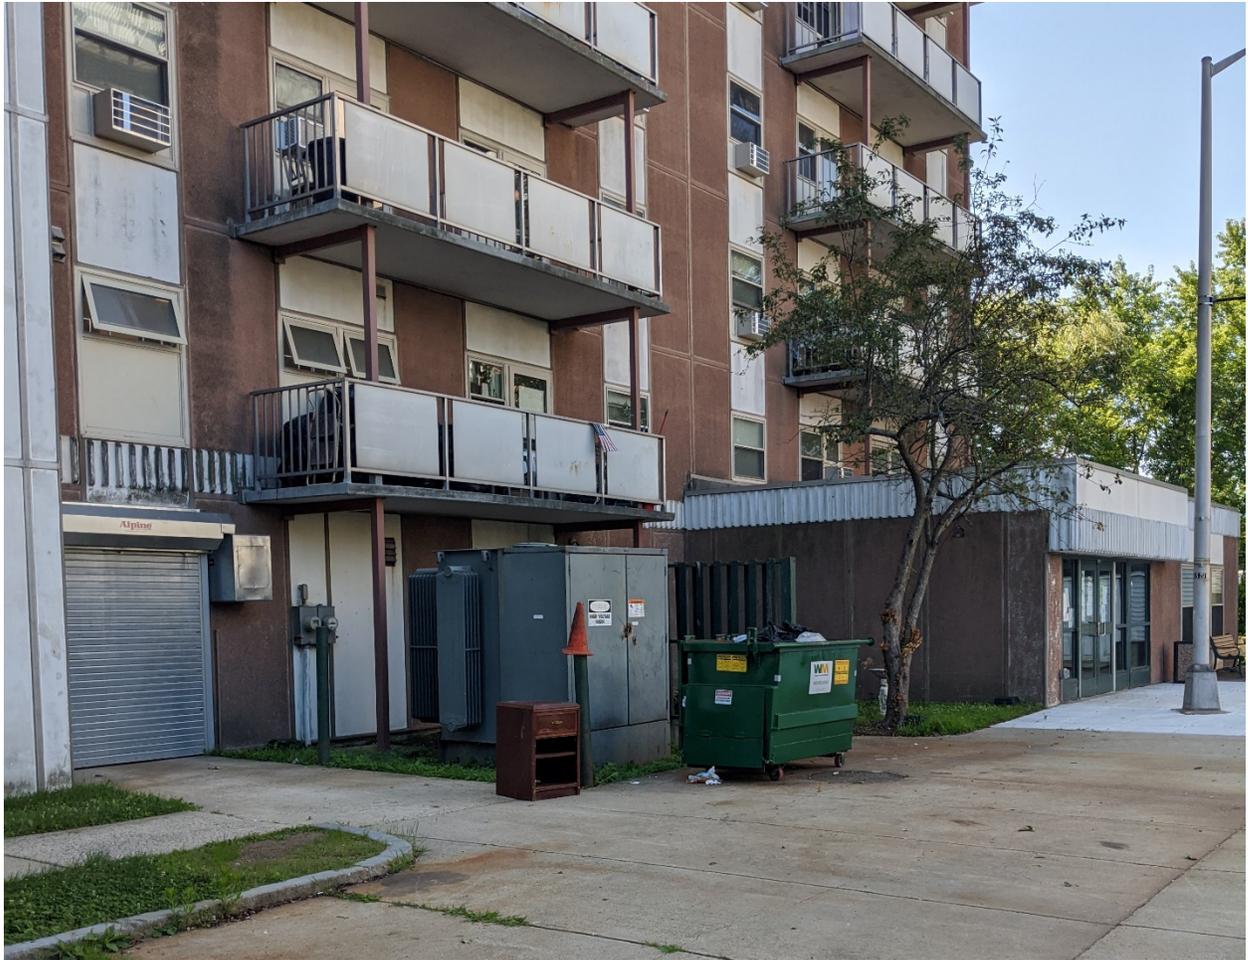
As noted in Part 1, much of the site, including all of Building B, is in a 100-year flood plain, but there are no resiliency or mitigation measures at the property. Critical infrastructure (including the main electric transformer, switchgear, building management and maintenance facilities) is located at grade, within the flood zone in Building B. The ground floor elevation at Building A is 2 feet higher and is thus slightly above the 100-year flood elevation. The buildings are low lying, putting them at risk of repeated flood events. As noted above, a flood a few years ago came within inches of the Building B ground floor. If the buildings are retained and renovated, flood barriers or other protection measures are required to protect the Authority's investment. A combination of berms, stormwater detention structures, and flood gates will be necessary.

*Figure 2.2: Building B transformer is located at grade level, within the flood plain and too close to building.*

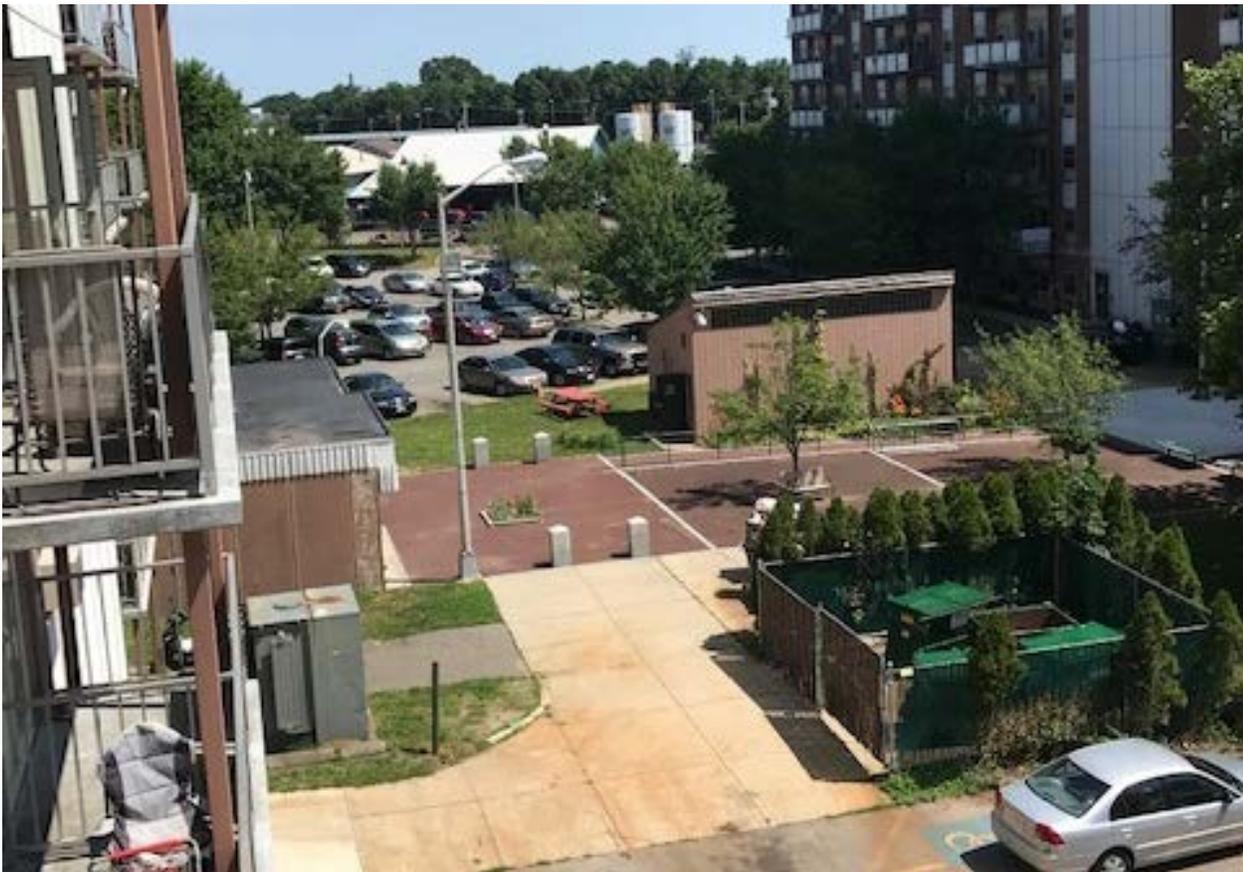
Figure 2.3: Central resident plaza between the buildings lacks amenity and shade.

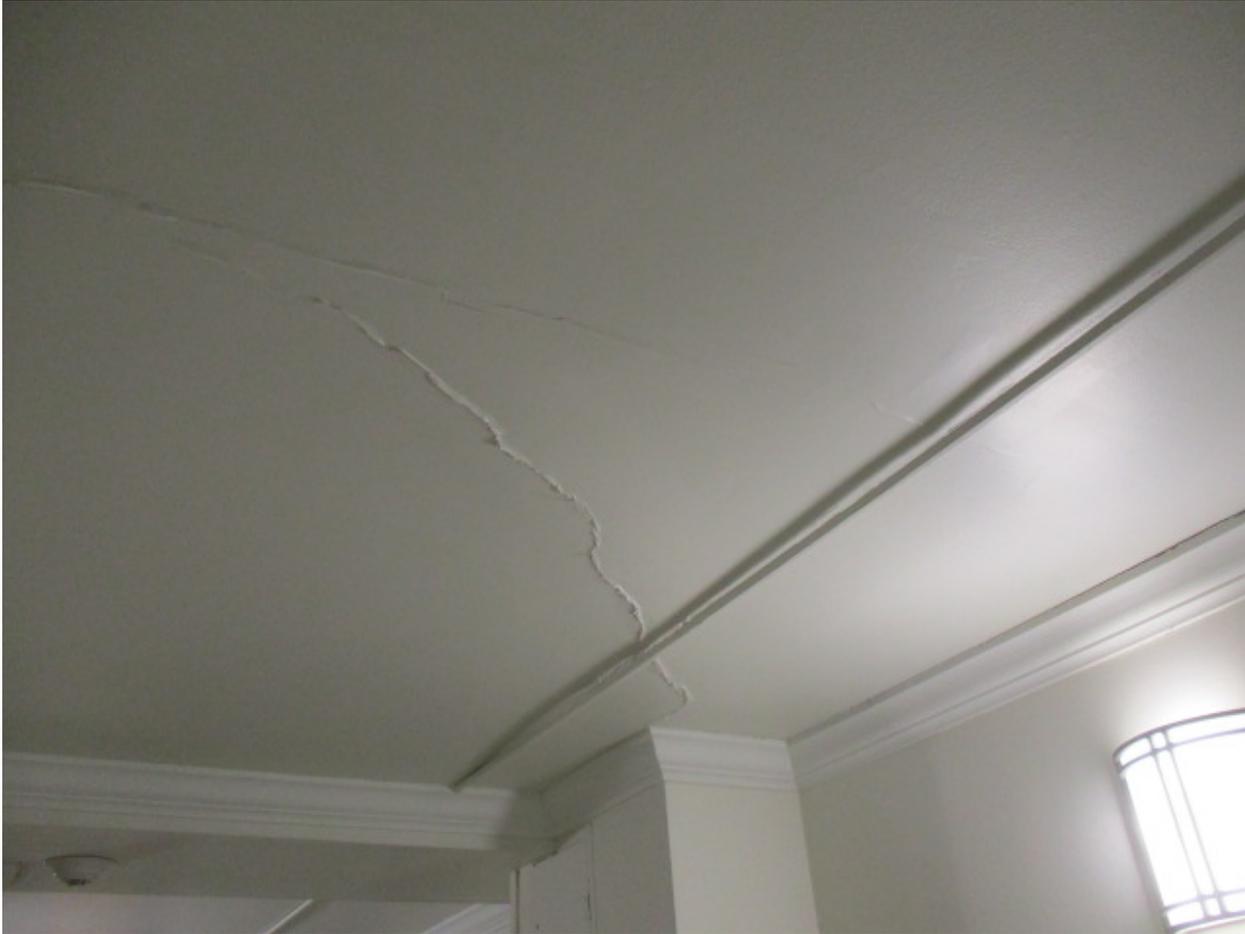
Subsequent analysis by our structural engineer confirms that these concerns are warranted: the vertical and lateral and seismic load-carrying capacity of the superstructure, roof framing, and floor framing systems are all inadequate relative to current code. While the buildings are highly unlikely to suffer catastrophic failure or collapse, their under-design means that excessive movement is present, causing damage to other systems. Among other deficiencies, movement may be contributing to the frequent breaks occurring in waste stacks (see Plumbing), as building movement creates stresses on the cast iron pipe stacks. PEDAs memo summarizing its findings is appended to this report.

Figure 2.4: Ceiling cracking caused by excessive structural movement.

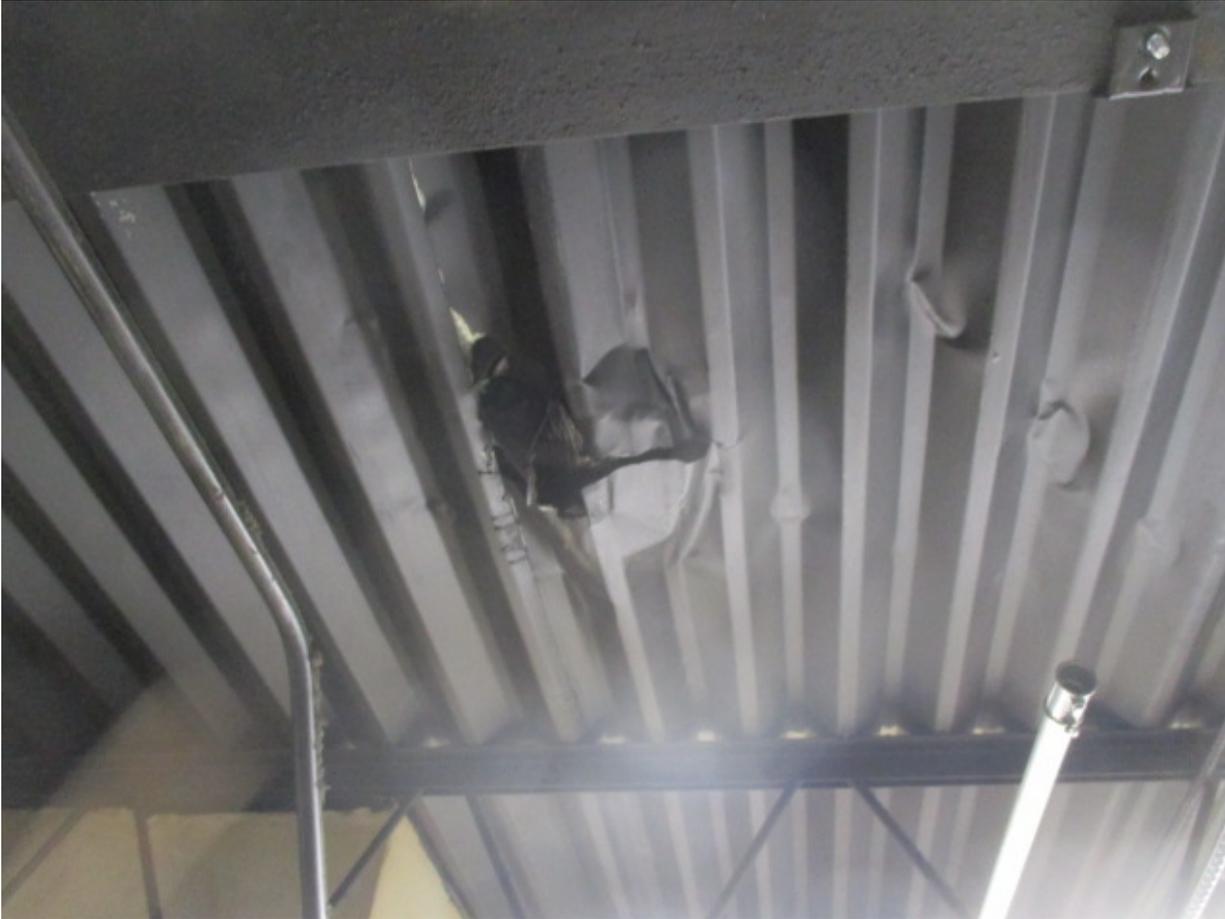
*Figure 2.5: Damaged metal decking from impact to floor above; this is a fairly typical condition.*

We did confirm, however, that the light-gage metal decking is not adequately secured to the bar joists and primary steel frame. PEDAs reports that for decking of this weight, the deck flutes should be tack welded at a spacing of 12 inches o.c. maximum. Our inspection of limited areas where the deck was visible indicated that most decking is welded to the bar joists very infrequently (greater than 48 inches o.c. or more). (See Figures 1.3 and 2.5) The major concern with this deficiency is that the floor system typically is designed to act as a diaphragm against lateral movement. If the joists and deck are not properly secured, they do not perform the intended function.

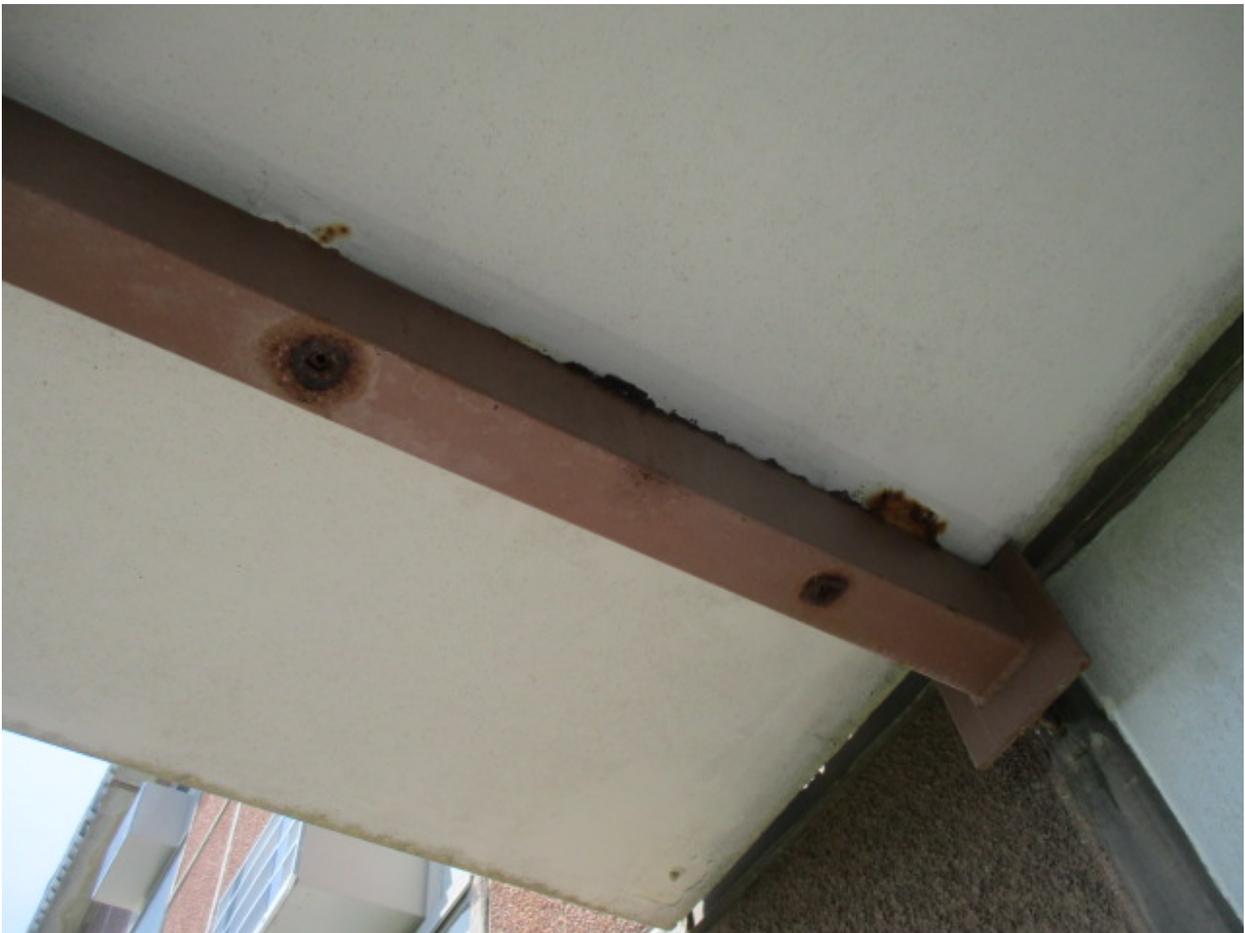
Exterior balconies are exposed steel with precast concrete deck; many are in poor or very poor condition and require immediate repair. The attachment details at the exterior balconies are highly suspect: they are vulnerable to ice and water damage, and we noted that many steel supports are badly corroded. The exposed exterior steel connections also act as a thermal bridge, transmitting cold to the structural frame and create condensation. Many steel and deck components require replacement now. Property maintenance records indicate that a number of balcony frames have already been replaced; many more will require replacement in the next three years. Water is entering at some attachment points. If the balconies are to be retained (see Building Envelope section for more on this issue), the exposed portions of the steel structure must be protected from further corrosion and water penetration.

*Figure 2.6: Heavy corrosion at exposed balcony steel (typical); also note deterioration at wall penetration*

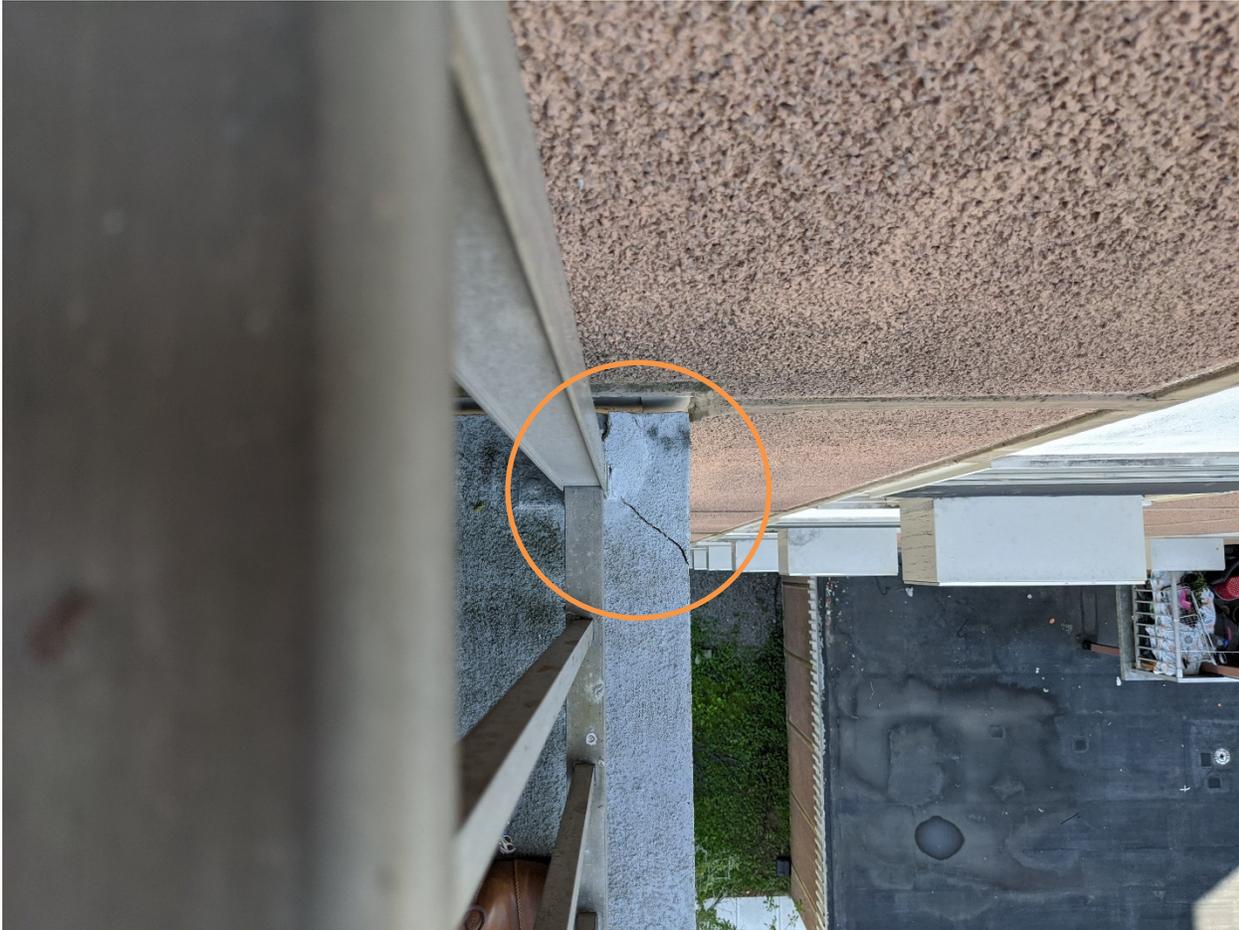
The steel balcony railing stanchions are attached to the precast decks by partially embedded stanchion plates. This detail is highly vulnerable to water intrusion and freeze-thaw cycling. We noted number attachments, even in recently repaired balconies, that are cracking spalled or otherwise showing distress. (Figure 2.7 on following page.) Inadequate distance from the stanchion post to the edge of the precast plank may also be contributing to

cracking. In either case, the cracks indicate that the railing will no longer support its designed load; this is potentially significant life safety issue.

*Figure 2.7: Spalling stanchion attachment in a recently repaired balcony.*

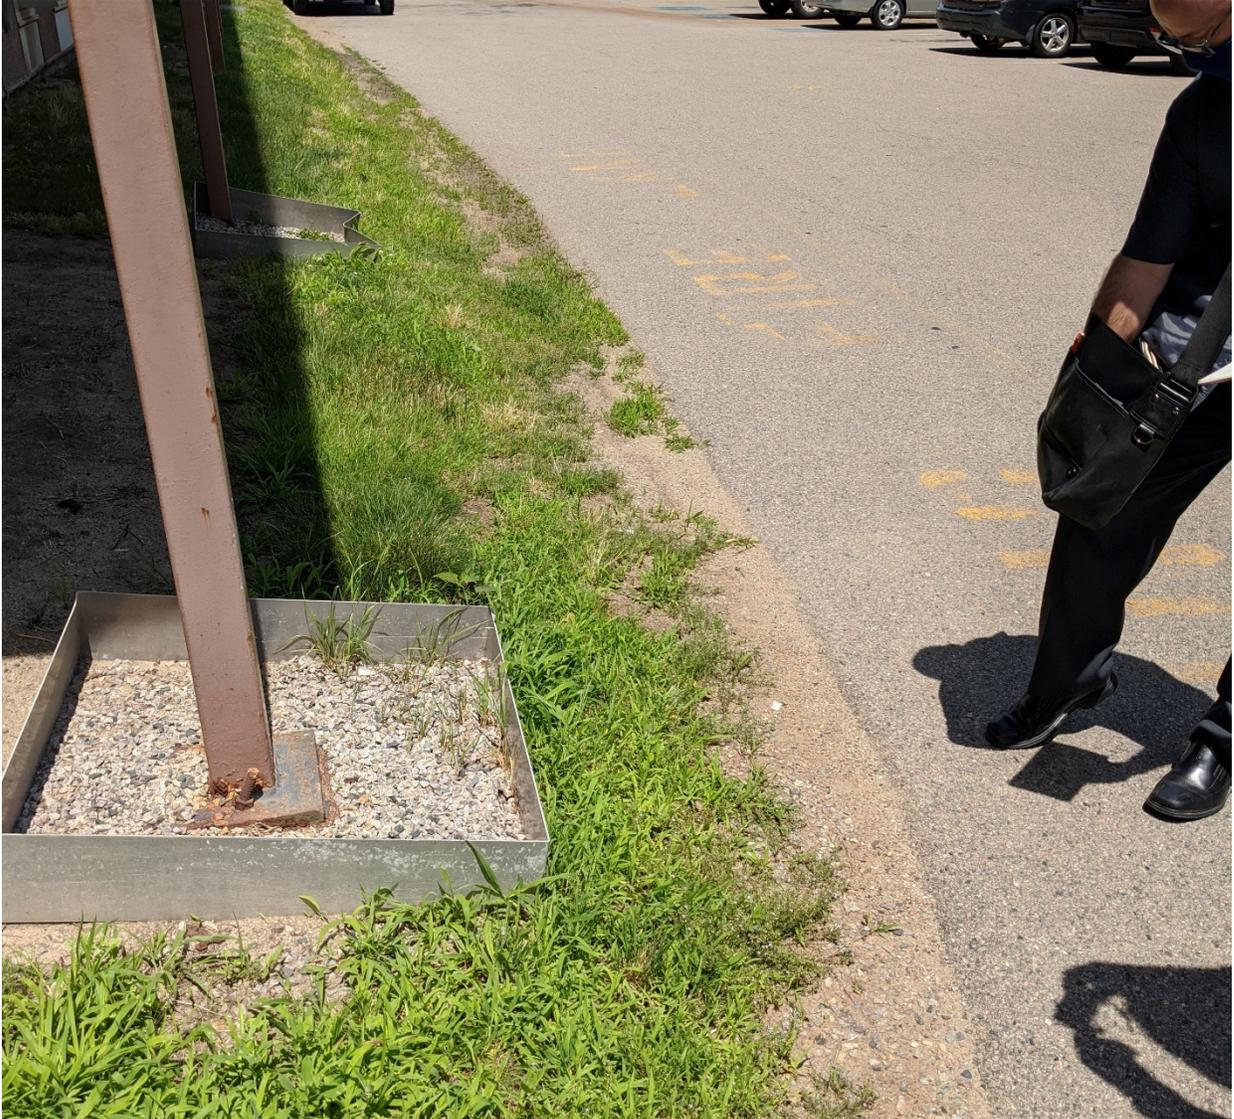
Another concern with the balconies is that the first floor support columns are highly vulnerable to corrosion and vehicular impact from the adjacent parking areas and roadways. The columns lack raised footing to get them out of the water and salt zone; most are heavily corroded. (Figure 2.8 on following page) A vehicle hitting one of these columns could bring down the entire balcony stack above. If the balconies are maintained in their current configuration, bollards or other protectives are required; ideally they should be replaced with shorter columns on raised concrete footings.

*Figure 2.8: Balcony column bases are badly corroded and subject to vehicular impact.*

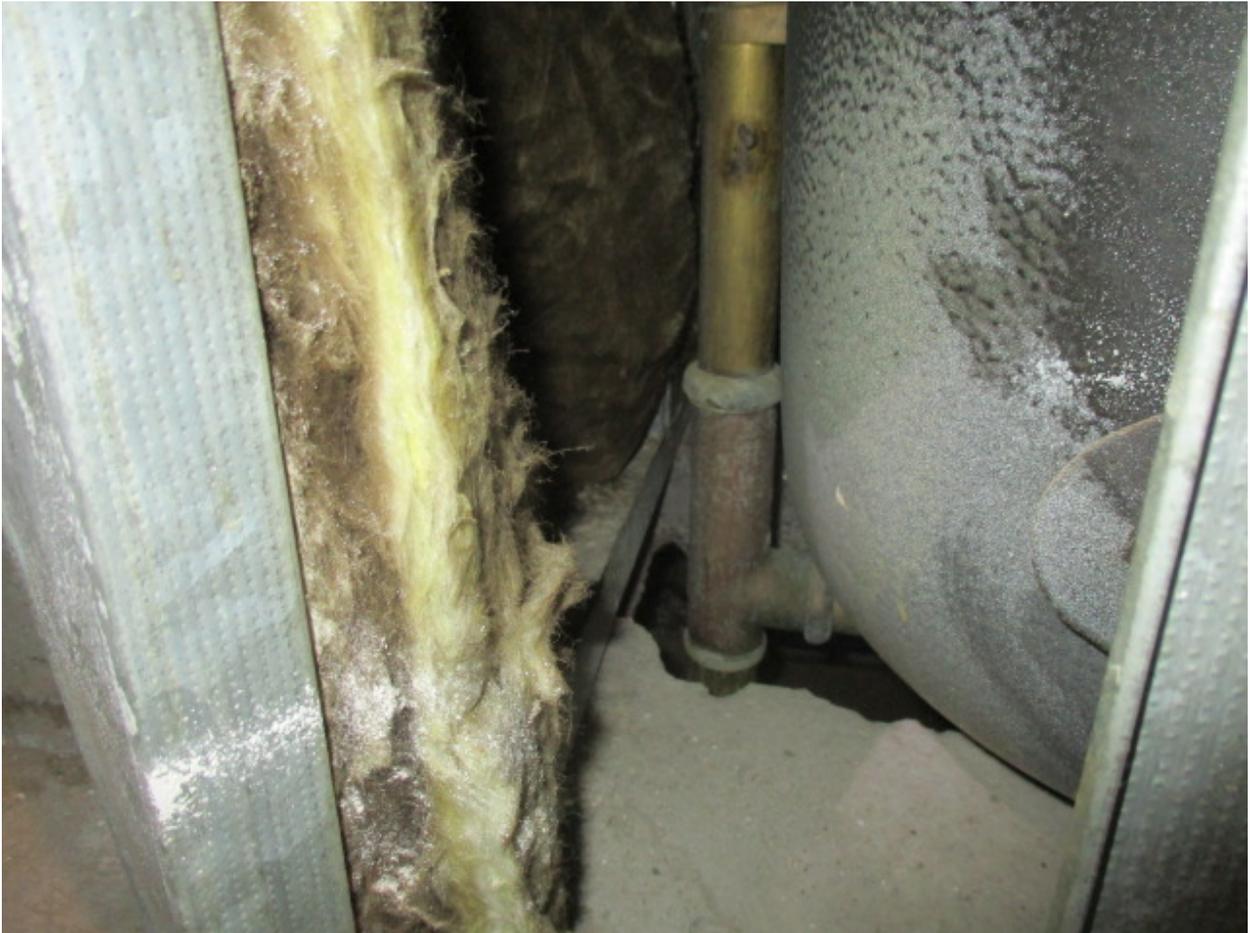
Finally, extensive fire-resistive construction (firestopping and fire-separation assembly reconstruction) is required to restore the original fire ratings of wall and floor/ceiling assemblies that have been compromised by almost 50 years of use, maintenance, and modernization work. (In many cases, it appears that the appropriate fire-resistive construction were never installed; another original construction deficiency.) At test cuts we observed, we consistently found missing or compromised firestopping assemblies, both at floor penetrations and partition walls. (See Figures 1.3 and 2.9 for two typical examples of missing firestopping and fire separation assemblies.) Other assemblies and spray fireproofing have been damaged by past plumbing leaks. When interior modernization work is undertaken, an extensive campaign of firestopping and fireproofing will be required for code compliance. This work must be coordinated with the structural repairs discussed above.

*Figure 2.9: Missing firestopping below tub drain; missing fire separation wall behind tub head.*

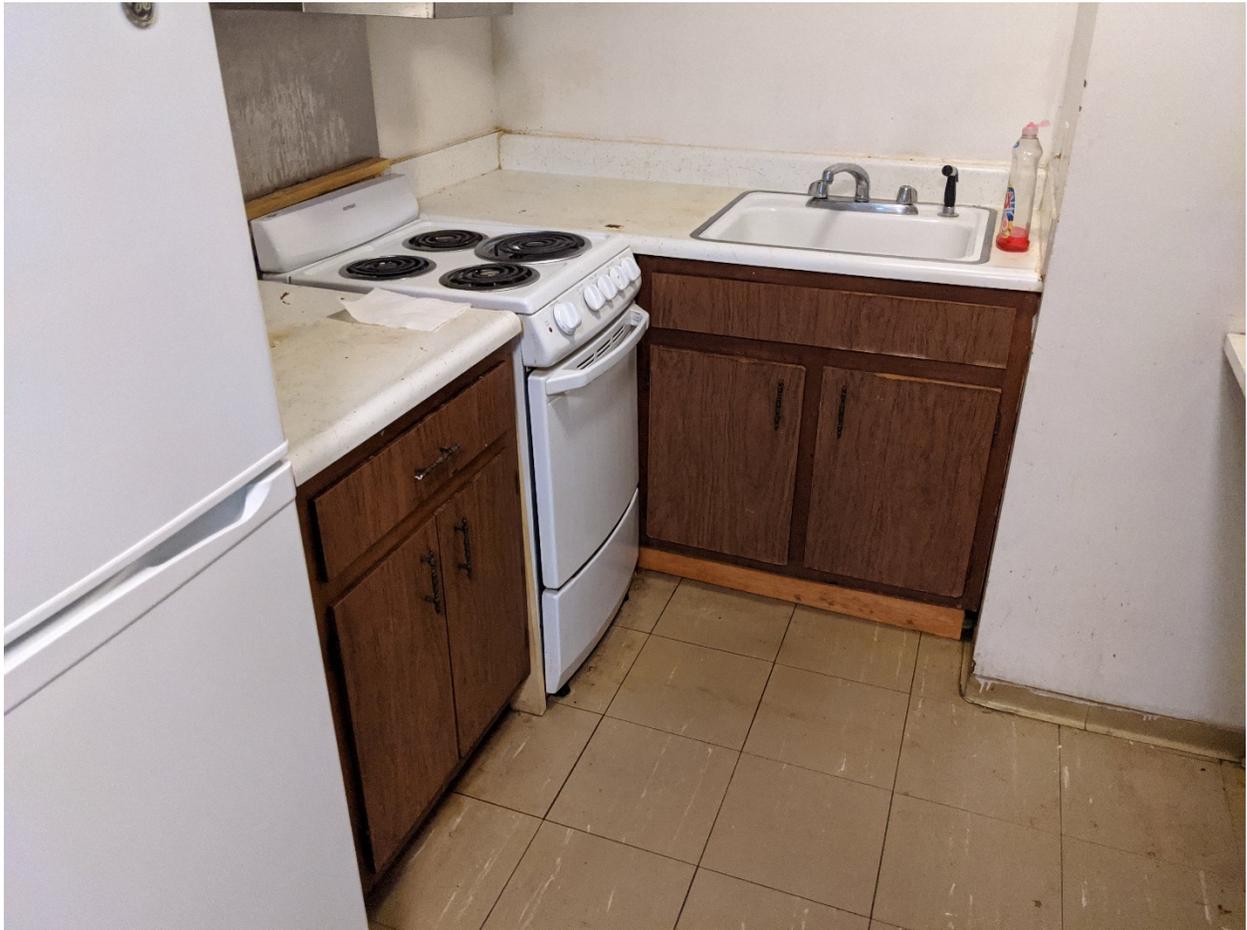
*Figure 2.10: Typical apartment kitchen. Note worn/delaminating door fronts, worn countertops, missing toe kick at sink base, lack of counterspace, lack of receptacles, and VAT tile floor in poor condition.*

Kitchen cabinets have solid wood face-frames and door and drawer fronts; most are badly work and delaminating from 48 years of use. (Figure 2.10) We

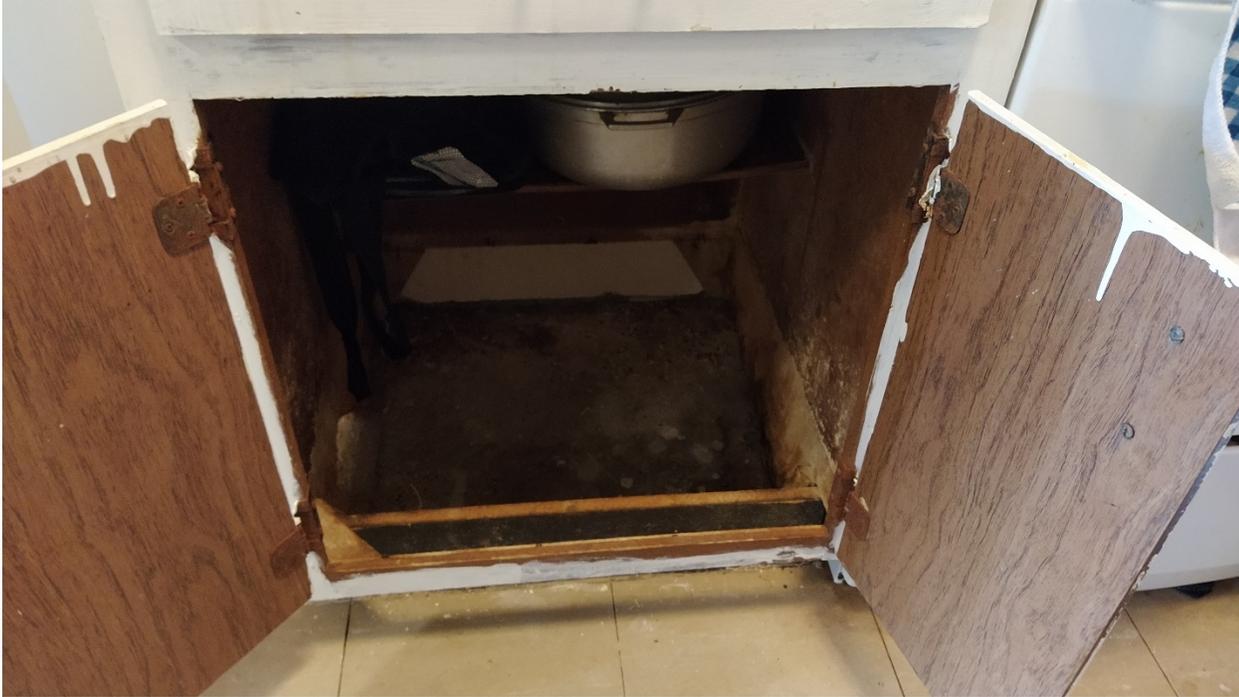
observed numerous cabinet doors, drawers and cabinet shelving that have failed. (Figure 2.11) Countertops are plastic laminate, also of varying ages and condition; some were wearing through the finish surface or delaminating at edges. (See Figure 2.10 on previous page.)

*Figure 2.11: Sink base in occupied apartment missing bottom shelf; this is a sanitary code violation.*

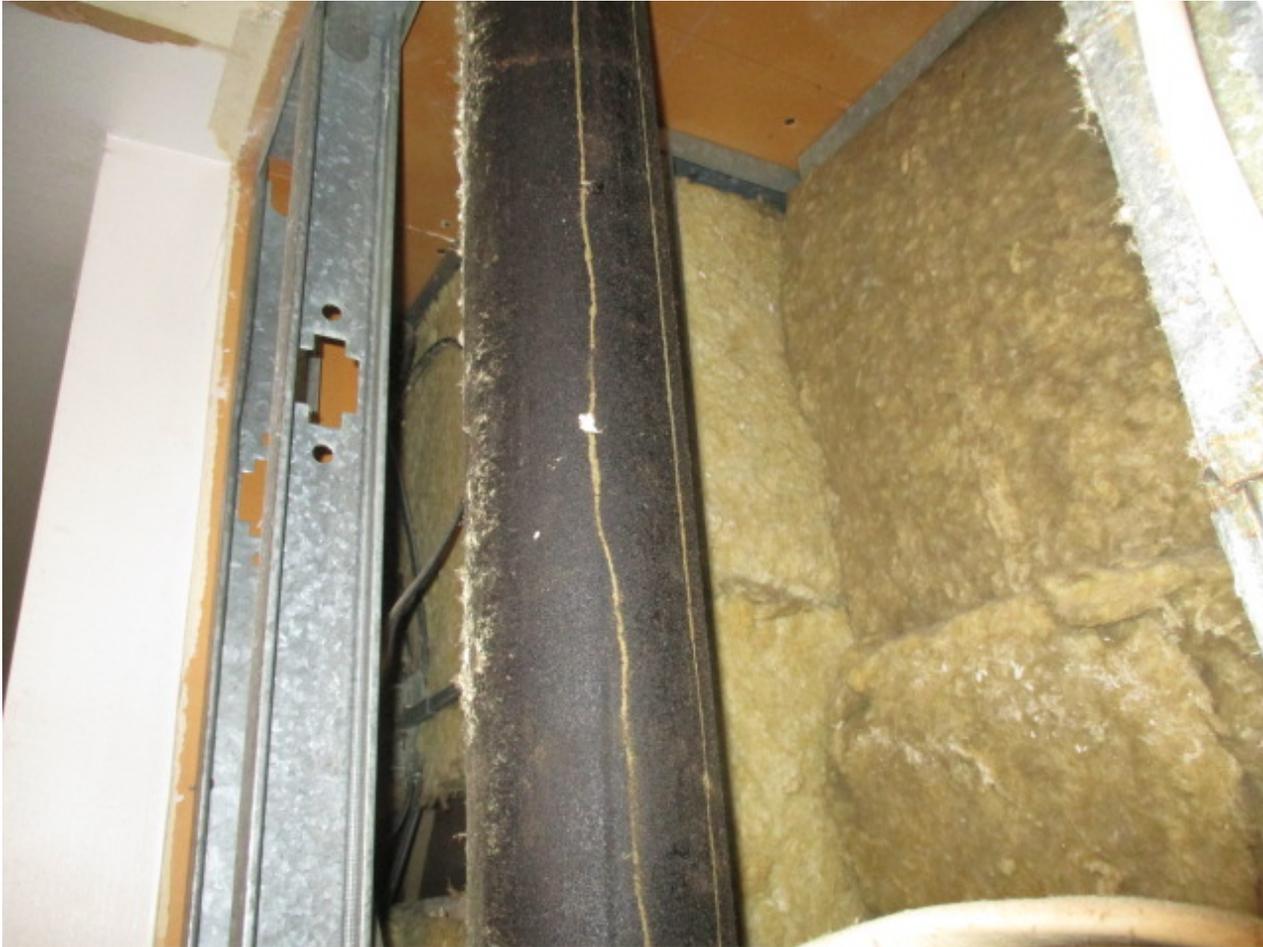
stacks and vents we were able to inspect, confirming the presence of leaks in the stacks. (Figure 2.12) Management reports frequent back-ups that it believes to be caused by scale build-up at the sweeps at the base of the stacks; management has opened and replaced a few badly scaled sweeps. Scaling increases the frequency of clogs that require snaking/jetting.

*Figure 2.12: Recently active leak at waste riser (note rust stains and streaks)*

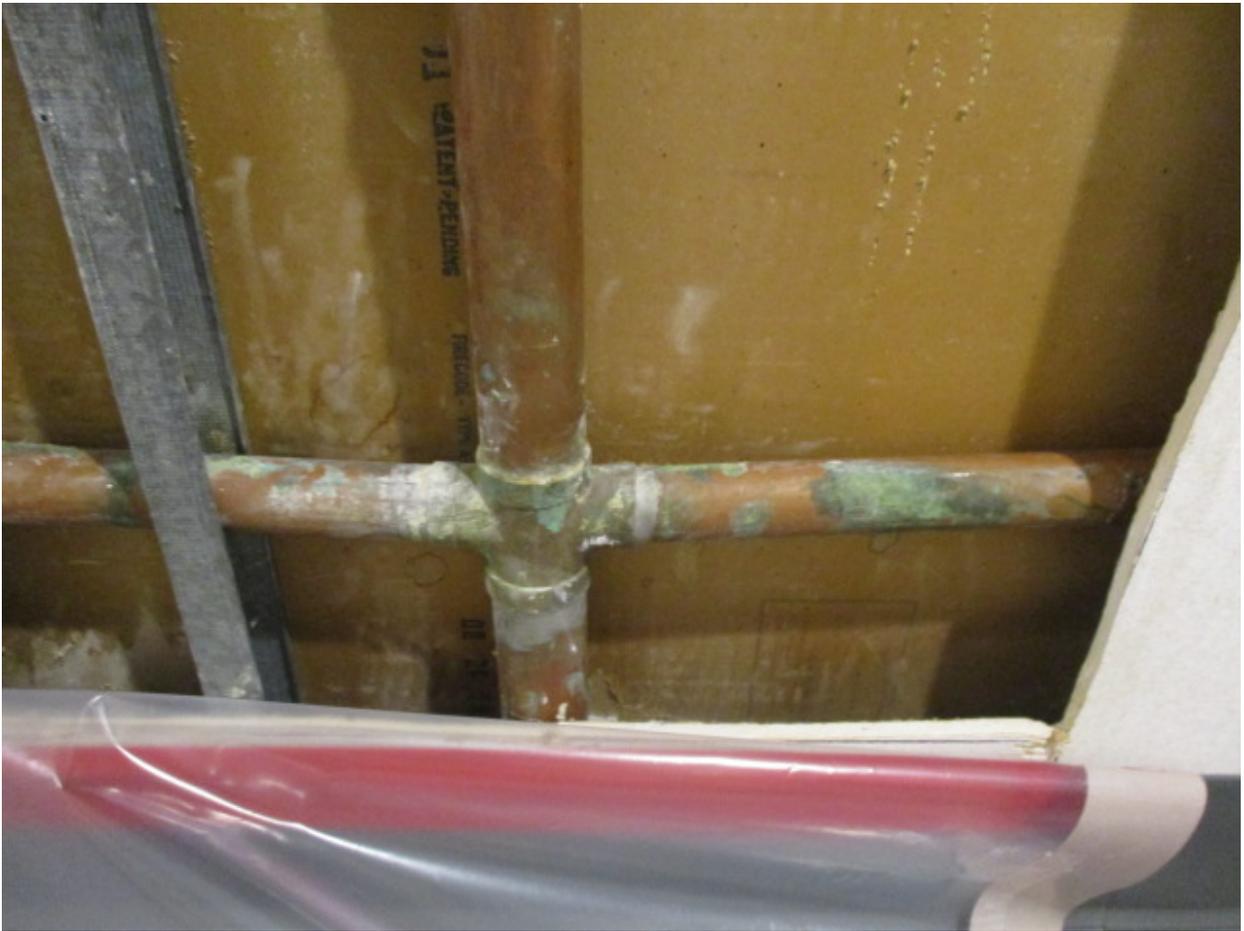
The copper branch waste piping is also heavily corroded and pitted throughout all areas we could inspect. (See Figure 2.13 on following page.) In addition, management reports numerous failures of the tub shoe (drain fitting); many have rotted out or separate from the copper

*Figure 2.14: Corroded and pitted copper branch waste piping; this is typical*
