13 January 2021

**CAPITAL NEEDS ASSESSMENT**  
FOR  
**CAMPELLO APARTMENTS**

BWA Project No. 2009A

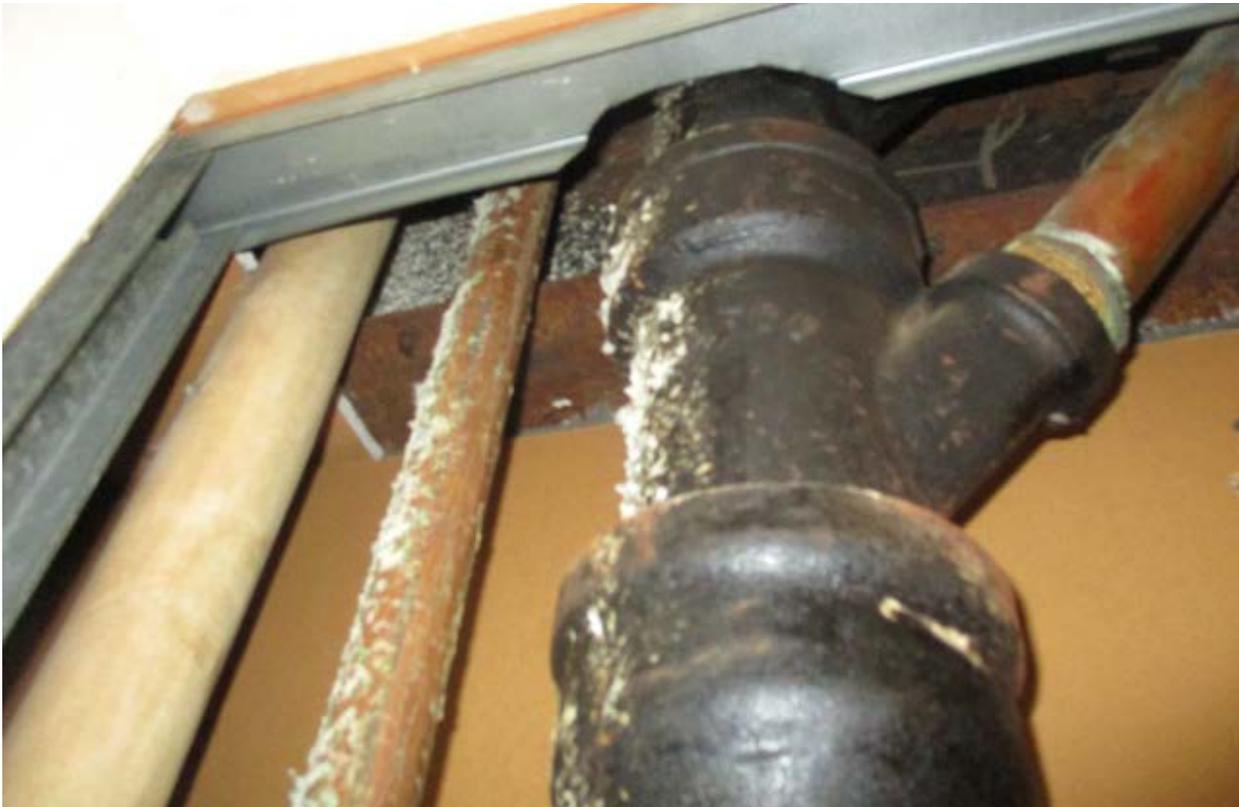
*Figure 2.15: Heavily corroded and pitted copper domestic supply riser (typical condition); also note lack of firestopping at slab penetration*

Potable water piping is either Type L or M thin wall copper. The copper risers are experiencing multiple failures each year, and the copper is showing pitting and corrosion on both interior and exterior (Photo 1.7 and 2.15). Most domestic supply isolation valves have failed and do not hold properly, and

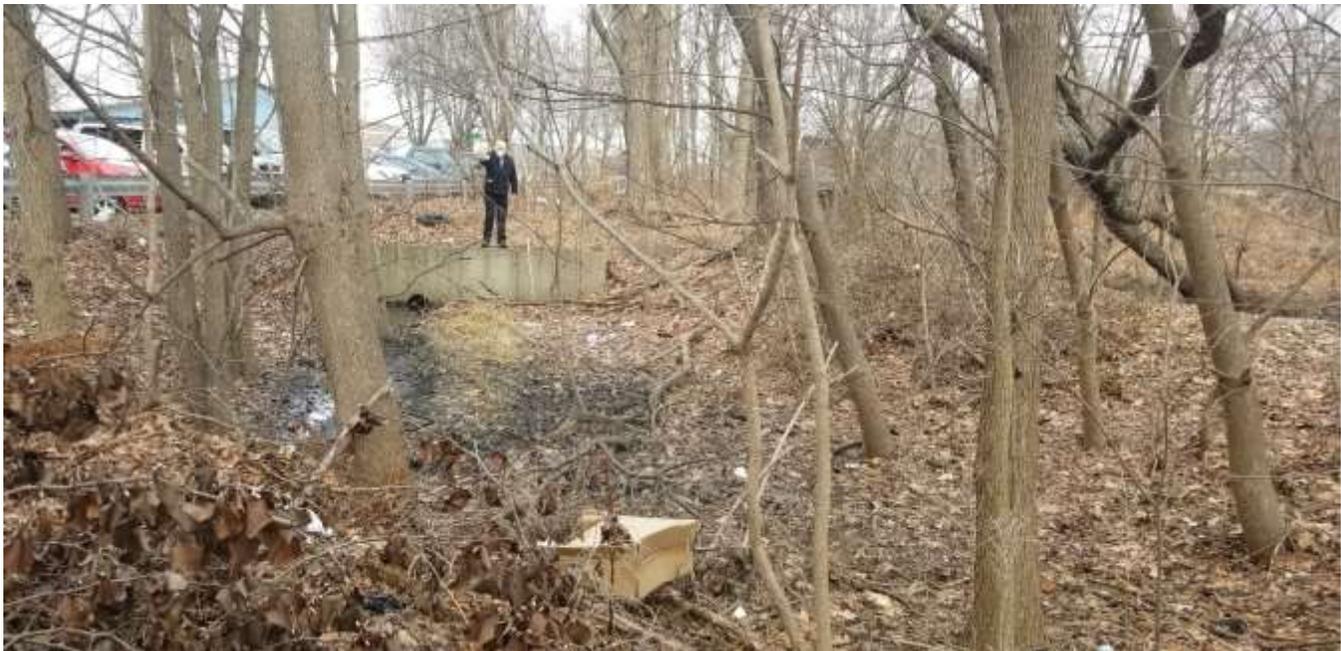
Aboveground water quality drainage swale with clogged inlet and outlet culverts.

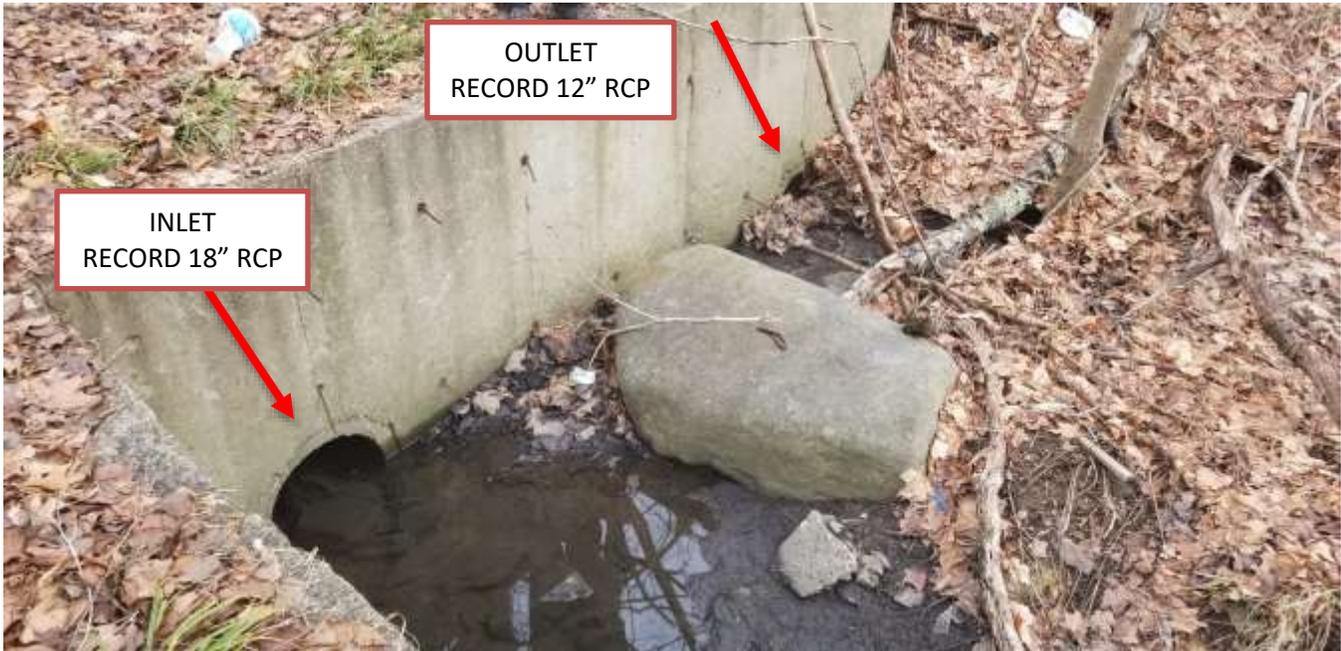
Aboveground water quality drainage swale with clogged inlet culvert.
