13 January 2021

**CAPITAL NEEDS ASSESSMENT**  
FOR  
**CAMPELLO APARTMENTS**

BWA Project No. 2009A

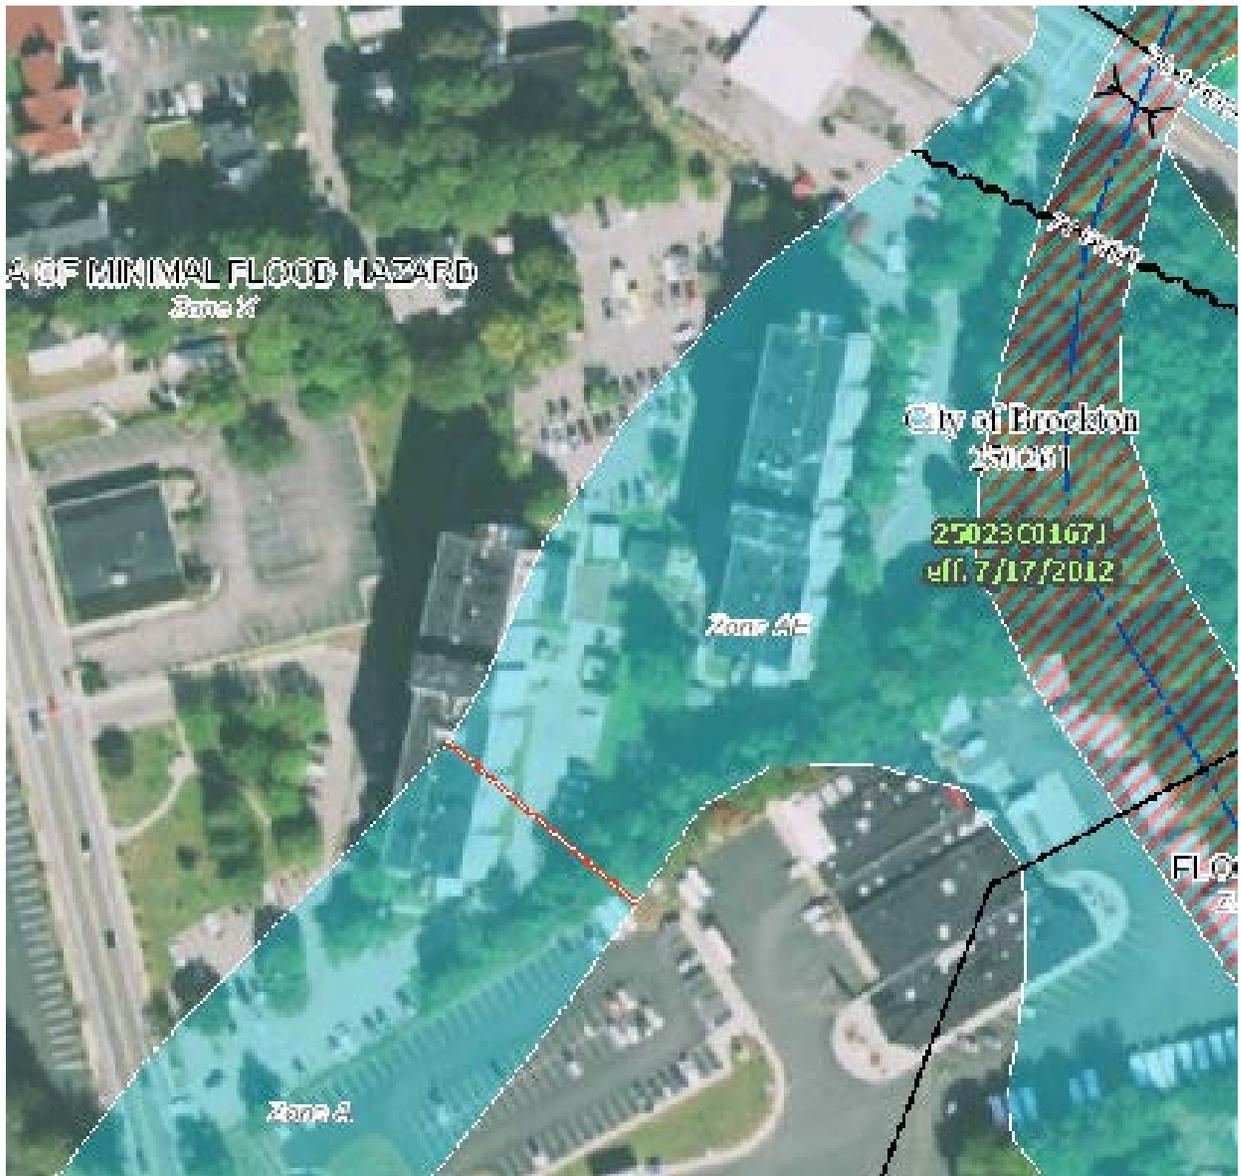
Besides the current deteriorating physical conditions, the buildings suffer from numerous code and regulatory compliance concerns that threaten their long-term viability. The first and perhaps most significant concerns their siting: most of the property, including the entire footprint of Building B and about half of Building A, is within the 100-year flood plain (Zone AE) associated with the adjacent Salisbury Plain River. This determination is found in the property flood map published by FEMA in 2009, a map which is now out of date and probably understates the flooding risk. (See Figure 1.2 on next page.) Zone AE indicates a high probability of annual flooding, and management reports that much of the site floods regularly during high rainfall events. The buildings' siting in the flood plain creates risks that are not currently protected against through resiliency measures. Most notably, the power transformer and main electrical switchgear serving both buildings is at grade level and within in the flood elevation, as are

all first floor services, including property management and maintenance facilities. A severe storm could render both buildings uninhabitable for months. A flood event three years ago required sand-bagging entrances and exits at Building B to prevent water intrusion.

Figure 1.2: FEMA Flood Map for the property; buildings are partially or completely within the flood plain

As the Authority considers what to do with Campello, the flood risk should be thoroughly considered: if major resiliency measures are not undertaken, any capital improvements could be in jeopardy. Resiliency improvements may include a combination of active measures, such as installing operable flood gates at building entries, and passive measures such as regrading to create flood barriers and relocating critical infrastructure.

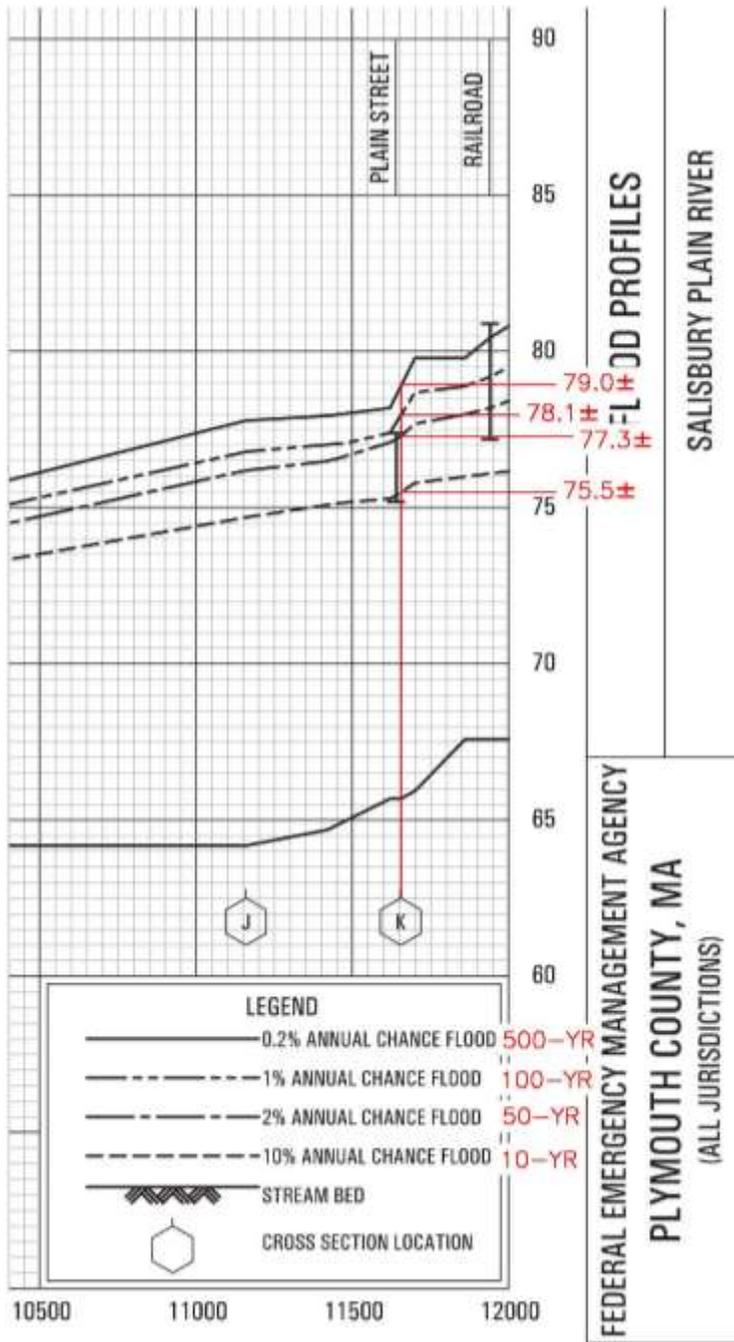
**FIRM Cross Section K – Upstream from Site**

<b>Flood Size</b>	<b>10-year</b> 10% Annual Chance	<b>50-year</b> 2% Annual Chance	<b>100-year</b> 1% Annual Chance	<b>500-year</b> 0.2% Annual Chance
<b>Elevation in Feet (NAVD88)</b>	75.5±	77.3±	78.1±	79.0±

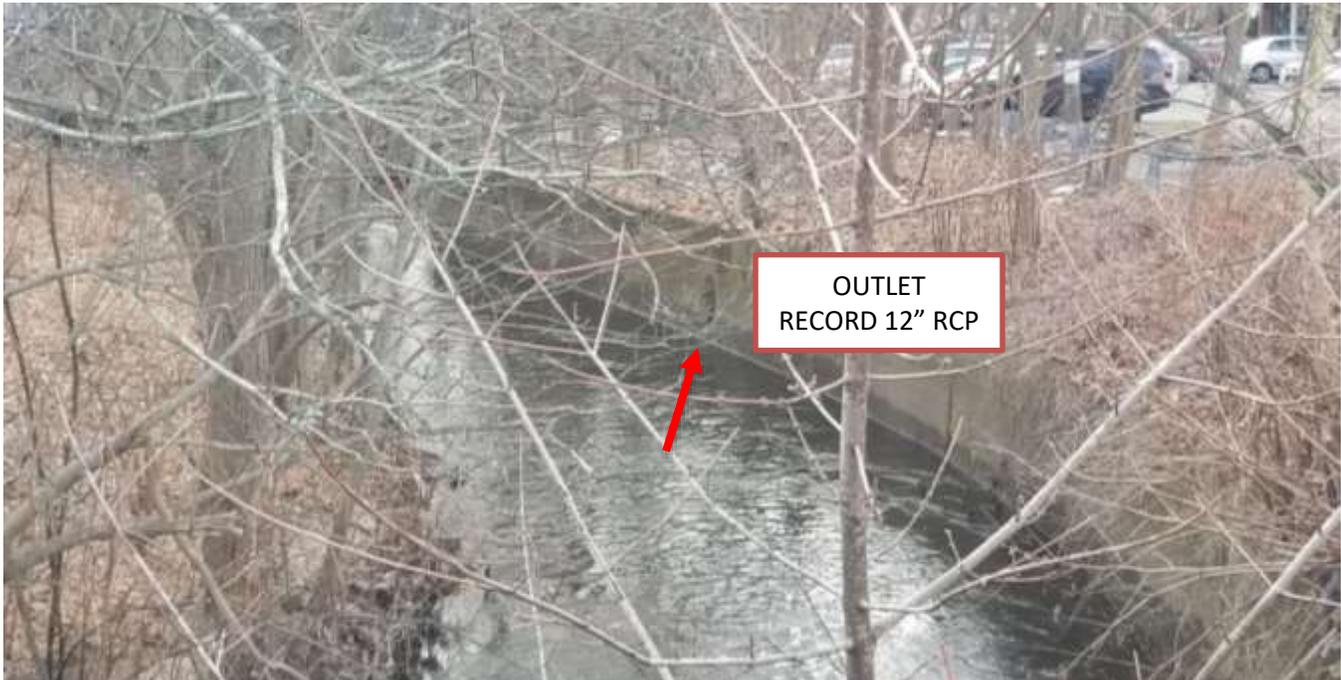
The remaining onsite closed drainage system outlets to Salisbury Plain River. During the December 28, 2020 site visit, the invert of the outlet pipe was near the water surface elevation of the Salisbury Plain River. If the river rose a foot or two, the outlet pipe would become partially submerged. As the river rises, the water from the river may back up in to the Site's closed drainage system.

Salisbury Plain River and Site drainage outlet.

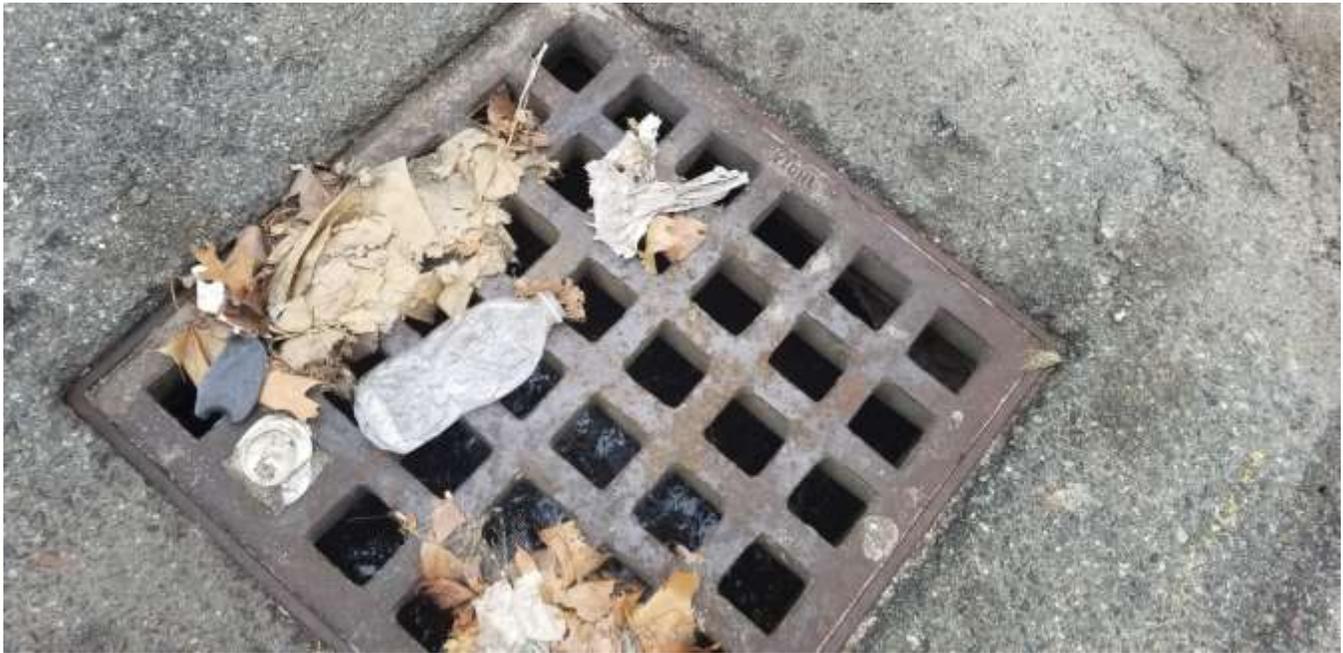
Catch basin full of water and debris.

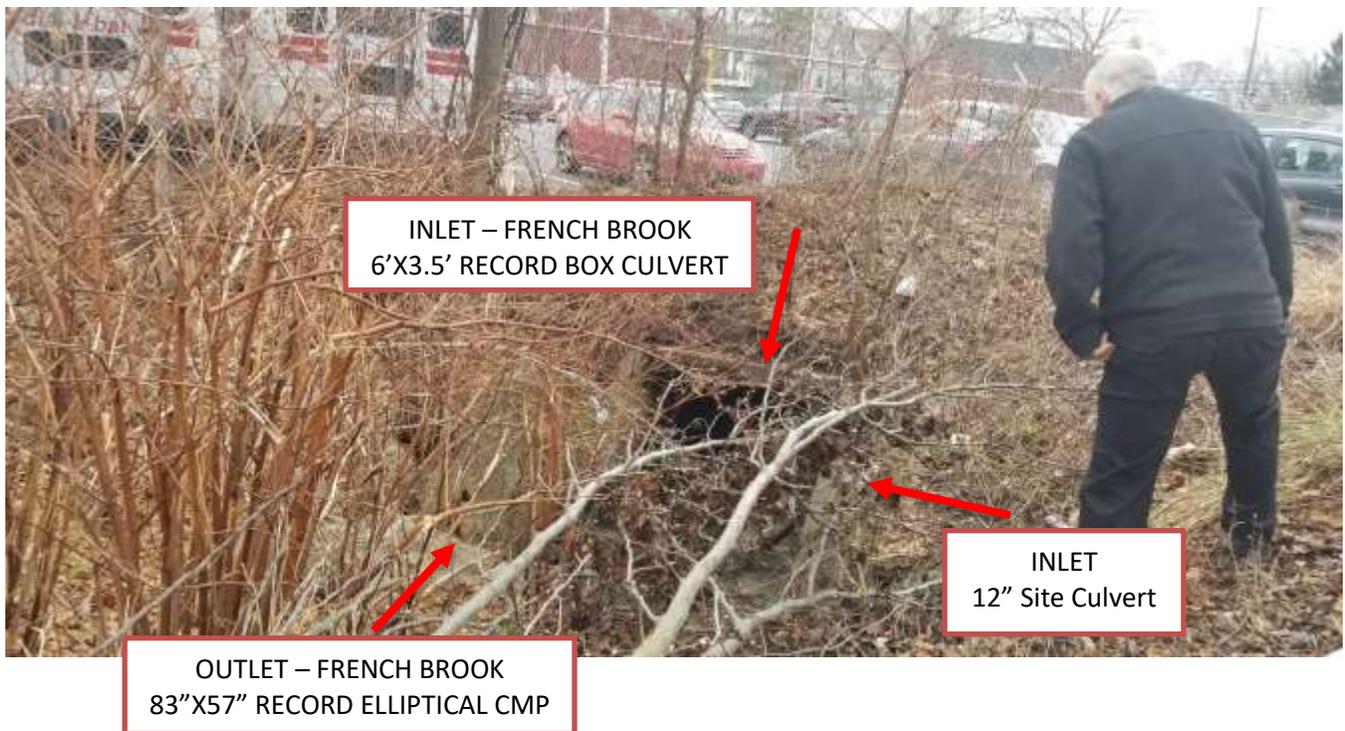
French Brook 6'x3.5' Box Culvert (inlet) and Site drainage 12" culvert (inlet) entering 83"x57" Elliptical CMP (outlet).
